**CR100A**  
**RECALL**  
**REVISION**

**NOTIFICATION AND DIRECTIONS**

**Revision Date: February 21, 2008**

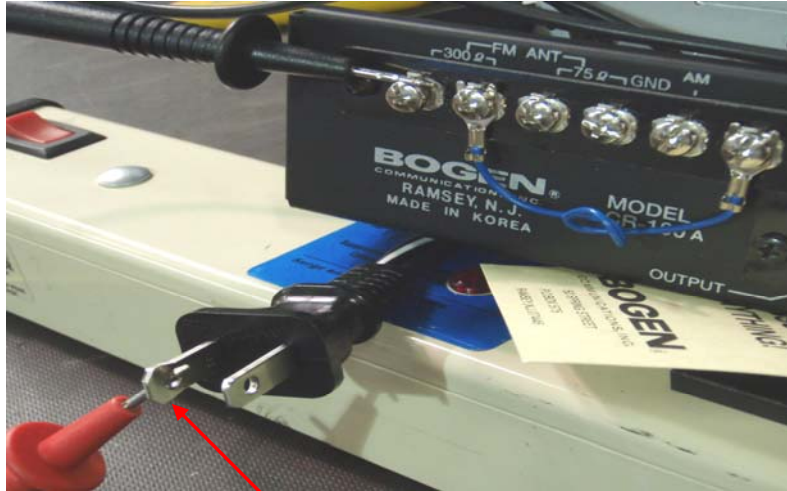
Neutral prong

**Test:** A simple test using a multi-meter will diagnose if the wrong resistor was installed. Please refer to pictures below.

Read the resistance between the neutral prong (wide blade) of the AC plug and the left most screw terminal, looking at the rear of the CR100A.

The resistance must read **greater than 9 Meg Ohms**.

If the resistance read is less than 9 Meg Ohms, the units must be repaired.

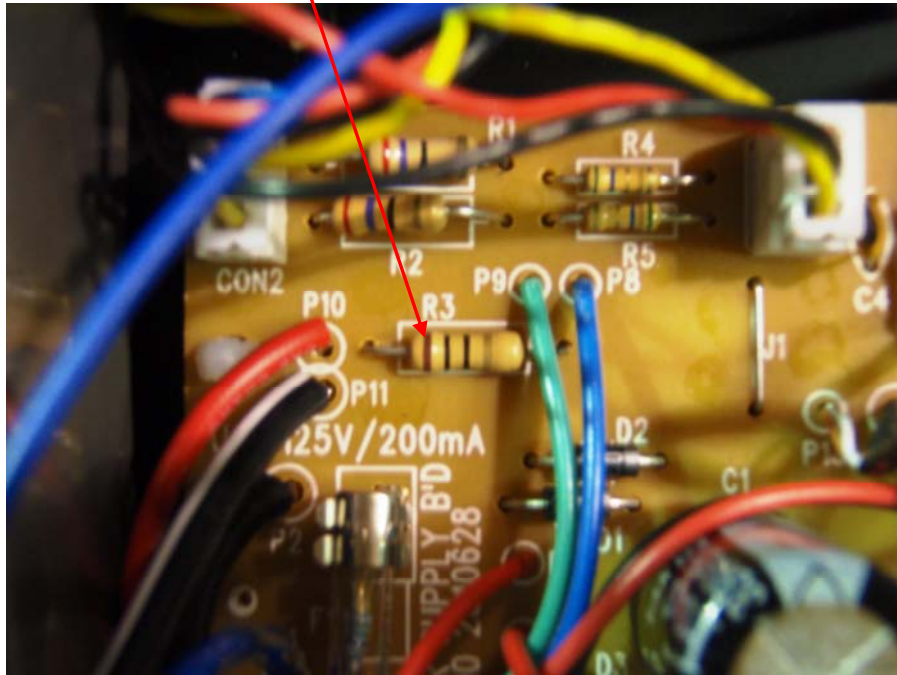
**Description:** An incorrect value for resistor R3 may have been installed in the suspect lot. The correct value for R3 is 10M ohm. The installed value may be 10 ohms. R3 is located on the power supply PC board. This resistor connects to the neutral terminal of the AC cord. This kind of connectivity is normally implemented by manufacturers in order to use the AC cord as an antenna. If the AC outlet into which the CR100A connects is wired incorrectly such that the neutral and the hot wires are reversed, the presence of high voltage on the left most screw terminal for the antenna connections may present a shock hazard if the unit contains the incorrect resistor.

1. Disconnect from AC line and remove the top cover of the CR100A.
2. Locate the resistor **R3** on the rear PC board of the CR100A.

3. Lift the PC board off the nylon stand-offs holding the PC board in place. Use needle nose pliers to pinch the tips of the stand-offs protruding through the PC board.
4. Remove the existing R3 resistor and replace it with a 10 Meg Ohm, ½ watt, resistor (color code Brown/Black/Blue, 4<sup>th</sup> band color does not matter).
5. Re-seat the PC board and replace the top cover.
